AsiaSat: A Real-World Case in Solving a Problem with BPF Installation

AsiaSat Engineering Department – White Paper

HU Hai, Senior Communications Systems Engineer, AsiaSat

April 2020

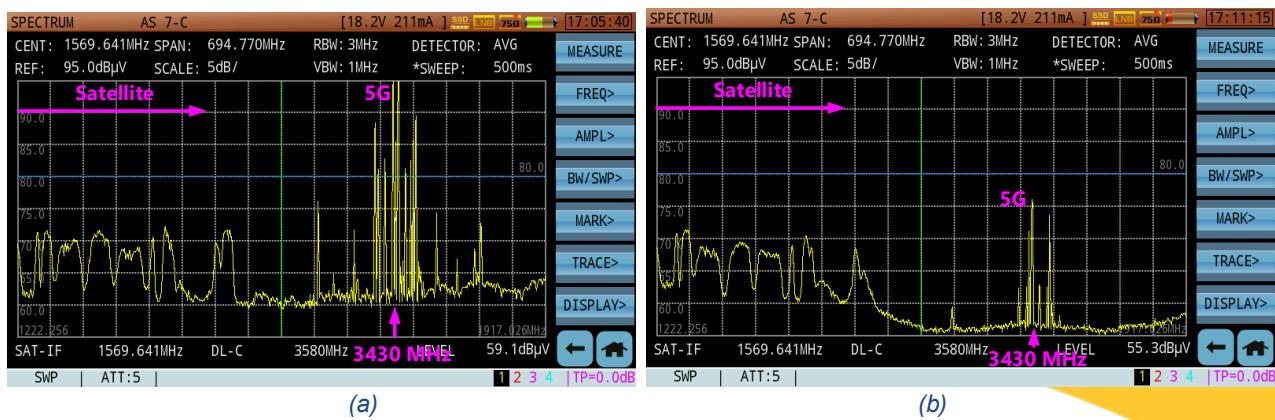
One of our customers has reported that a recently installed 5G BPF did not function as expected – interference still occurred intermittently and impaired the satellite TV reception. The spectrum plots before and after BPF installation are shown in **Figure 1(a) and (b)**.

It can be seen from **Figure 1(a)** that there was intensive 5G interference at around 3430 MHz, with a bandwidth of about 60 MHz. After the BPF installation, interference was reduced by only 20 dB, as shown in **Figure 1(b)**, performing at a far lower level than the > 60 dB rejection level that AsiaSat BPF-3700S filter was designed to provide. The 5G interference to the TVRO system remained strong and “robbed” the satellite carrier power from the low noise block-downconverter (LNB), putting up mosaics on the TV screen.

Figure 1 Spectrum at the TVRO LNB output: (a) before, and (b) after BPF installation.

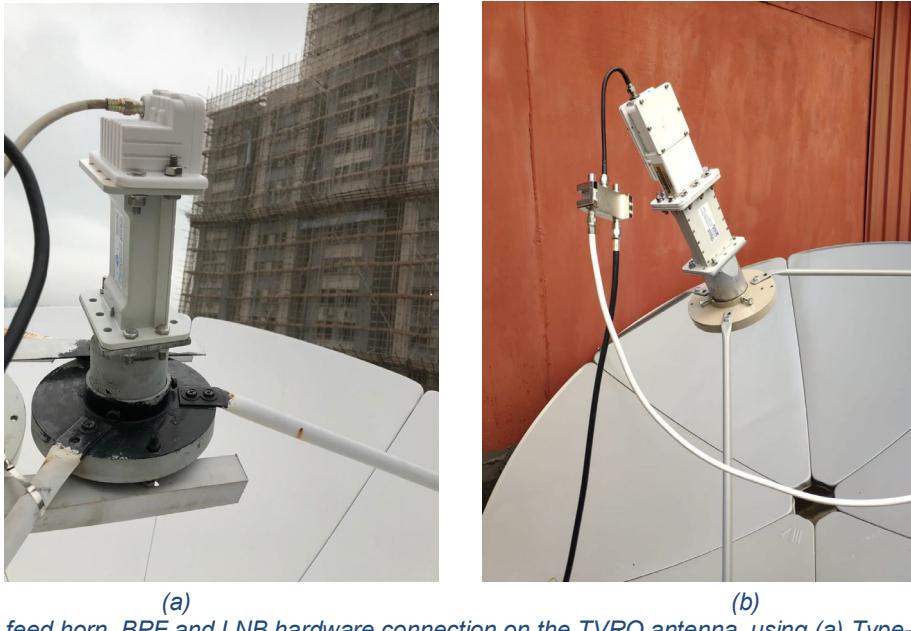
The customer sent us a close-up photo showing the connection on the TVRO equipment which is shown in **Figure 2(a)**. It was a front-fed TVRO, and the *Type-A LNB* used by the customer was of a light-weight type secured by four screws and has a non-standard waveguide interface. The LNB was enclosed in a plastic shell and appeared not to be fully EMI-shielded.

For the sake of comparison and in an attempt to mitigate the problem, we asked the customer to repeat the spectrum measurement using a *Type-B LNB* with a full-metallic body and standard WR229 input interface. **Figure 2(b)** shows the hardware connection of the Type-B LNB, where 10 screws were used to secure the BPF. Unfortunately, there was no improvement in the level of 5G interference at the *Type-B LNB*'s output.

Figure 2. The feed horn, BPF and LNB hardware connection on the TVRO antenna, using (a) Type-A LNB, and (b) Type-B LNB. For Figure 2 (a), even the flange outer edges were not aligned, the waveguide openings of the LNB input and the BPF output were still aligned.

The guidelines are set out in **Table 1** below, with the most important tip being to make sure that the BPF-LNB interface is tightly connected. If the LNB used is similar to the one shown in **Figure 2(a)**, it may be better to upgrade it with a model having standard waveguide flange and full-metallic body enclosure. For a step-by-step installation guide, please watch the video on **our website**¹.

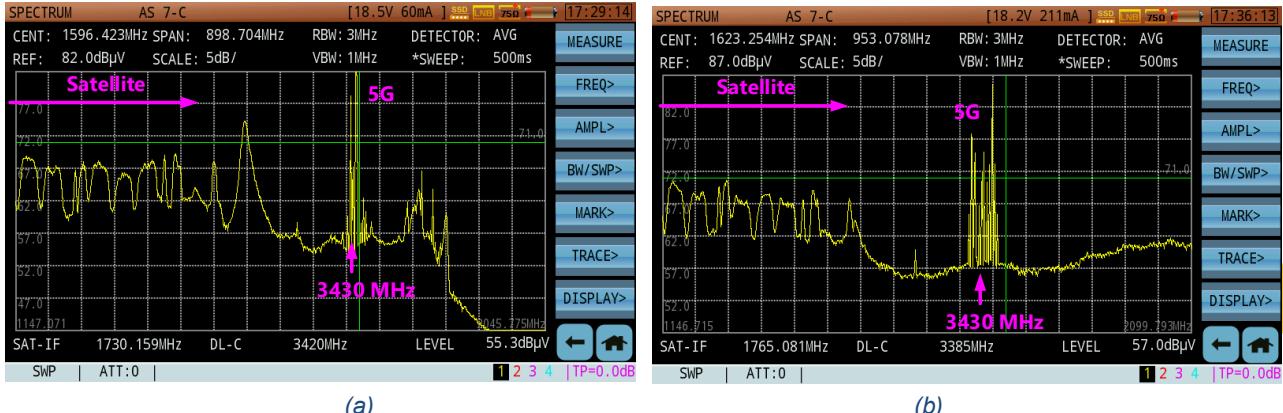
The spectrum plots comparison is shown in **Figure 3**.

Figure 3. Spectrum at the TVRO LNB output, using (a) Type-A LNB and (b) Type-B LNB.

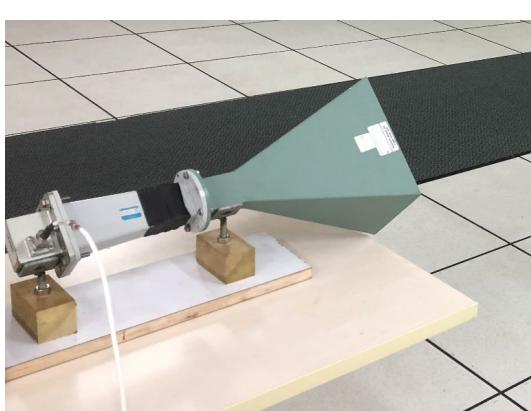
As a first step, we took an interference scan with a standard C-band horn antenna (see **Figure 5**). The horn was connected to a hand-held spectrum analyser, and we manually scanned the horn in all possible directions with max-hold spectrum plot. The scanning results confirmed that the 5G interference generally came from the rooftop of the adjacent building in the pointing direction of the satellite dish.

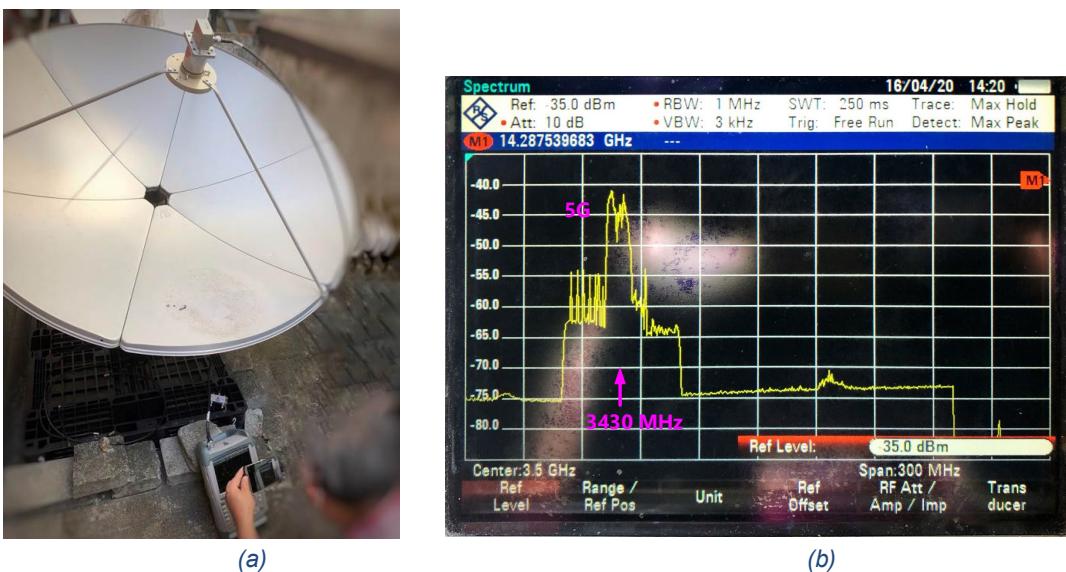
The second diagnosis step was to take 5G interference measurements directly from the antenna feed output as shown at **Figure 6(a)**. The corresponding spectrum was max-held for more than 5 minutes and shown at **Figure 6(b)**. It can be seen that the interference was in the typical 5G spectrum shape, where the inner 15 MHz wide plateau was made of 5G synchronising signal blocks (SSB) which were broadcast and used for establishing the links between the base station and the 5G end user equipment. The estimated 5G power picked by the satellite dish antenna was less than -33 dBm, which should have had no noticeable impact to the satellite carriers if the BPF had functioned normally.

Figure 6 5G interference measured at the antenna output port: (a) the test setup and (b) the max-hold spectrum plot.

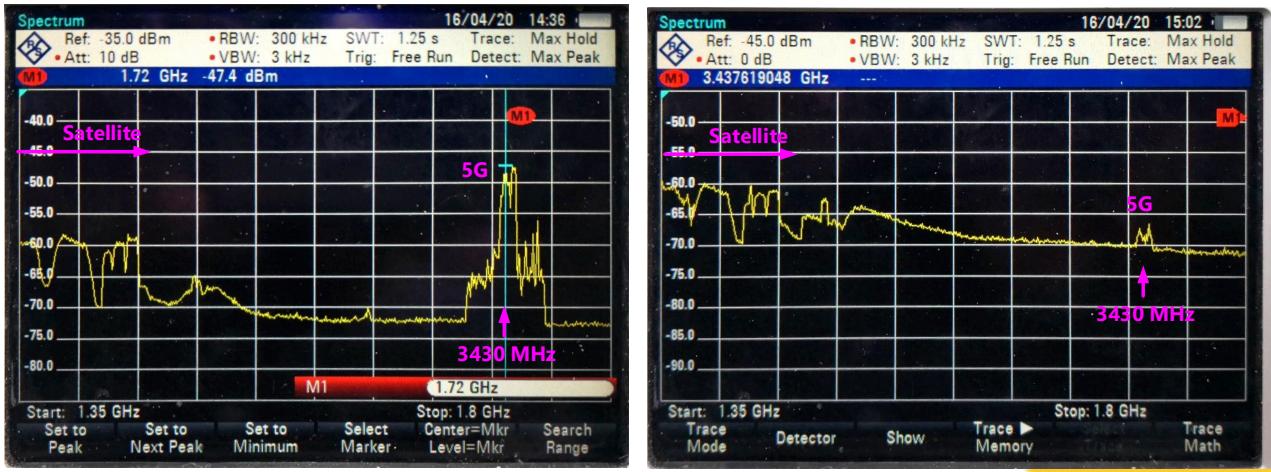
The third diagnosis step was to inspect the BPF-LNB interface and tighten the screws. First, the BPF-LNB junction was removed from the feed horn. After careful inspection, no gaps or cracks at the BPF-LNB interface could be observed, and all the screws were fastened as shown in **Figure 2(b)**. However, as we tried to tighten the screws, we found that 7 out of the 10 screws were not tightly fastened. The spring lock washers under the screw head were only slightly loaded. After tightening all the screws, we mounted the BPF-LNB junction back onto the feed, and the 5G interference was found to have gone immediately. **It turned out that an imperceptible gap between the LNB and the BPF was the culprit!** The spectrum plots comparison before and after the screw tightening is shown in **Figure 7**, and it can be seen that the tightened BPF-LNB interface has helped to reduce 5G interference by 20 to 25 dB.

Figure 7 Spectrum plots at the Type-B LNB output: (a) before and (b) after tightening the BPF-LNB interface screws.

In this White Paper, a typical problem with BPF installation is diagnosed and eventually solved. The cause of the partially-rejected interference is the insufficiently tightened BPF-LNB waveguide flange interface where the 5G signal could be directly coupled in without passing through the BPF. The solution is to simply tighten up all the screws between the BPF and LNB before re-mounting them onto the antenna feed horn. This White Paper provides some general diagnosis guidelines to help with BPF installation and troubleshooting.

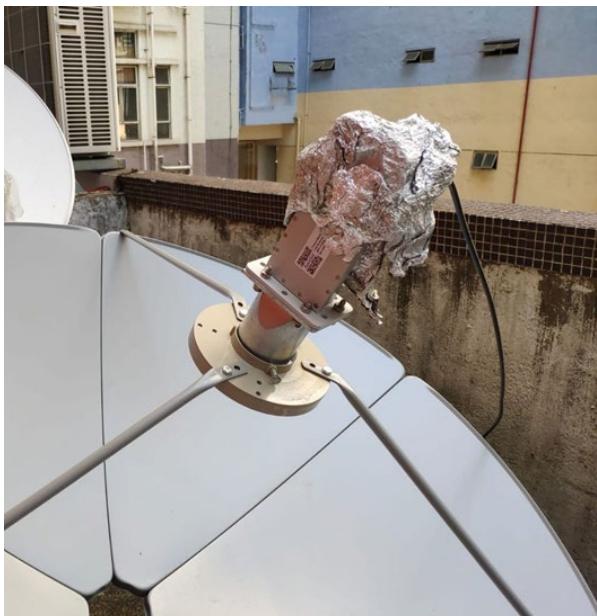
(a)

Figure 8(a) shows the final appearance of the LNB. Based on the tests, we suspected there was a leakage from the *Type-A LNB* (e.g. gaps or simply non-metallic body enclosure) in addition to the BPF-LNB connection interface. The tapes and aluminum foils may work as a temporary shielding, but their effects may be degraded by the elements over time.

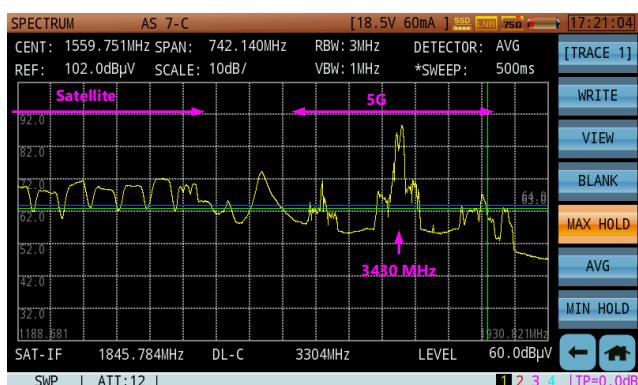
(b)

To further help the customer with the *Type-A LNB* as used in **Figure 2(a)**, we tried several ad-hoc shielding methods and tested their effectiveness. First, all four screws at the BPF-LNB interface were tightened. The resultant spectrum plot at the LNB output is shown in **Figure 8(b)** where the 5G interference signal was still strong.

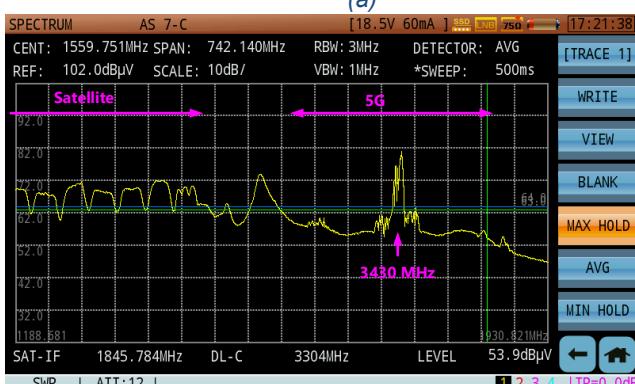
(c)

A layer of conductive tape was then applied to seal the BPF-LNB interface, and the corresponding spectrum plot is shown in **Figure 8(c)**. The conductive tape improved the shielding effect by only a few dBs.

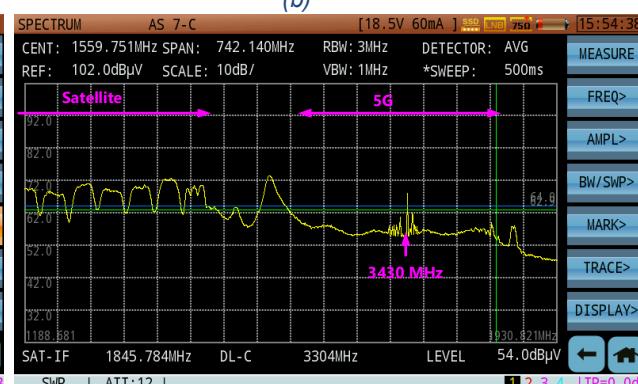
(d)

Finally, three layers of household aluminum foil were used to wrap the LNB, and the corresponding spectrum plot is shown in **Figure 8(d)**. It can be seen the conductive tape combined with the aluminum foils provided a total shielding effect of 20 dB, and the 5G interference has been reduced to an acceptable level.
