## AsiaSat: A Real-World Case in Solving a Problem with BPF Installation

AsiaSat Engineering Department – White Paper

April 2020 (Updated in December 2025)

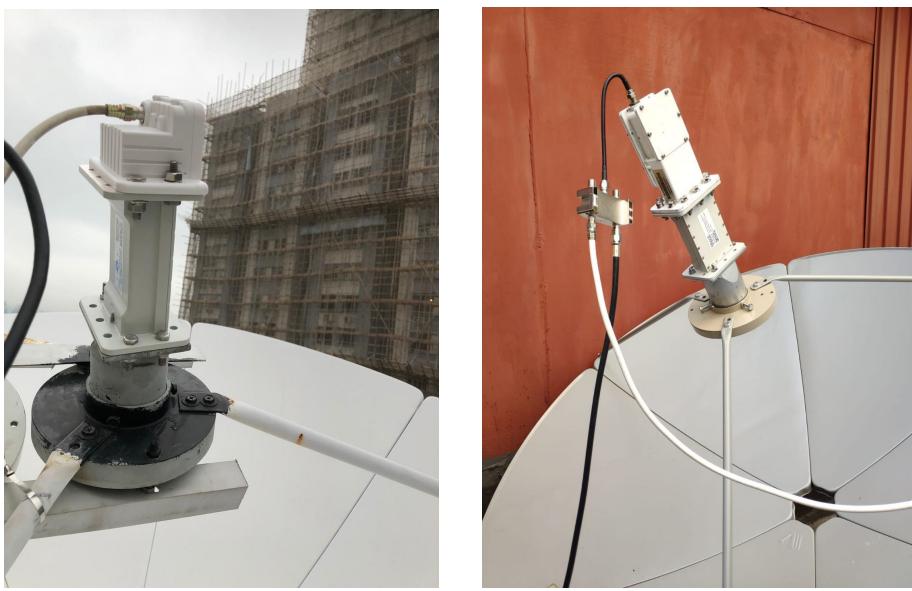
The customer sent us a close-up photo showing the connection on the TVRO equipment which is shown in **Figure 2(a)**. It was a front-fed TVRO, and the *Type-A LNB* used by the customer was of a light-weight type secured by four screws and has a non-standard waveguide interface. The LNB was enclosed in a plastic shell and appeared not to be fully EMI-shielded.

For the sake of comparison and in an attempt to mitigate the problem, we asked the customer to repeat the spectrum measurement using a *Type-B LNB* with a full-metallic body and standard WR229 input interface. **Figure 2(b)** shows the hardware connection of the *Type-B LNB*, where 10 screws were used to secure the BPF. Unfortunately, there was no improvement in the level of 5G interference at the *Type-B LNB*'s output.

**Figure 2.** The feed horn, BPF and LNB hardware connection on the TVRO antenna, using (a) Type-A LNB, and (b) Type-B LNB. For Figure 2 (a), even the flange outer edges were not aligned, the waveguide openings of the LNB input and the BPF output were still aligned.

The guidelines are set out in **Table 1** below, with the most important tip being to **make sure that the BPF-LNB interface is tightly connected**. If the LNB used is similar to the one shown in **Figure 2(a)**, it may be better to upgrade it with a model having standard waveguide flange and full-metallic body enclosure. For a step-by-step installation guide, please watch the video on our website<sup>2</sup>.

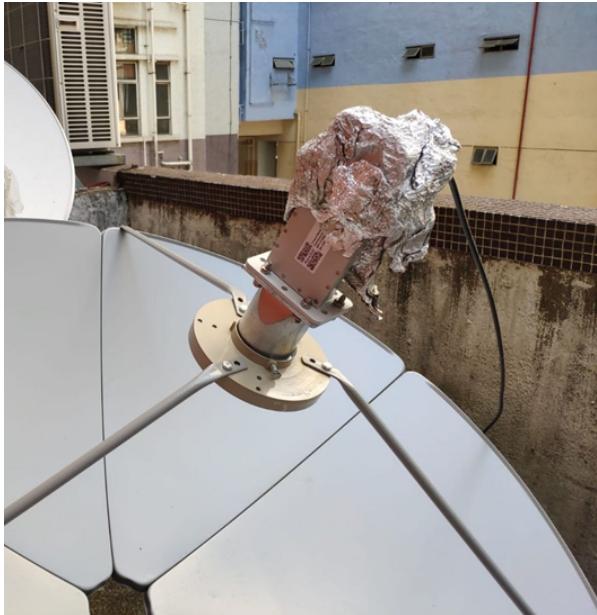
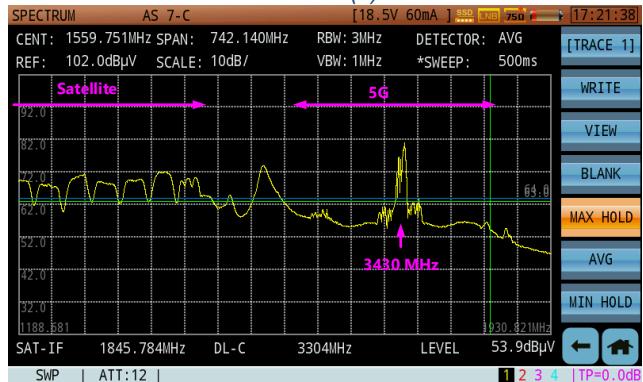
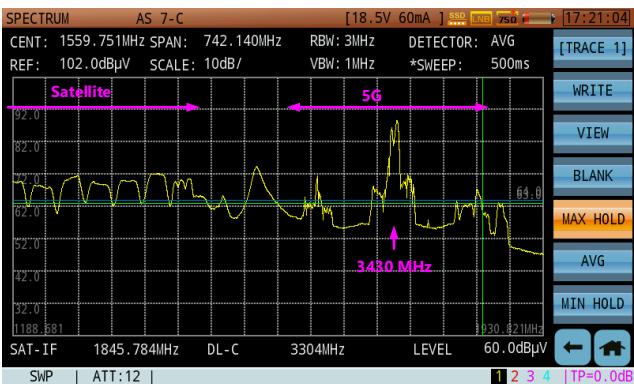
To further help the customer with the *Type-A LNB* as used in **Figure 2(a)**, we tried several ad-hoc shielding methods and tested their effectiveness. First, all four screws at the BPF-LNB interface were tightened. The resultant spectrum plot at the LNB output is shown in **Figure 8(b)** where the 5G interference signal was still strong.

A layer of conductive tape was then applied to seal the BPF-LNB interface, and the corresponding spectrum plot is shown in **Figure 8(c)**. The conductive tape improved the shielding effect by only a few dBs.

**Figure 8(a)** shows the final appearance of the LNB. Based on the tests, we suspected there was a leakage from the Type-A LNB (e.g. gaps or simply non-metallic body enclosure) in addition to the BPF-LNB connection interface. The tapes and aluminum foils may work as a temporary shielding, but their effects may be degraded by the elements over time.

**Figure 8** The ad-hoc shielding applied to the Type-A LNB: (a) the final appearance of the shielded LNB. The spectrum plots at the LNB output: (b) BPF only, no other shielding measures, (c) BPF with conductive tape sealing the BPF-LNB interface, and (d) LNB wrapped with aluminum foils in addition to the conductive tape sealing BPF-LNB interface.

Finally, three layers of household aluminum foil were used to wrap the LNB, and the corresponding spectrum plot is shown in **Figure 8(d)**. It can be seen the conductive tape combined with the aluminum foils provided a total shielding effect of 20 dB, and the 5G interference has been reduced to an acceptable level.

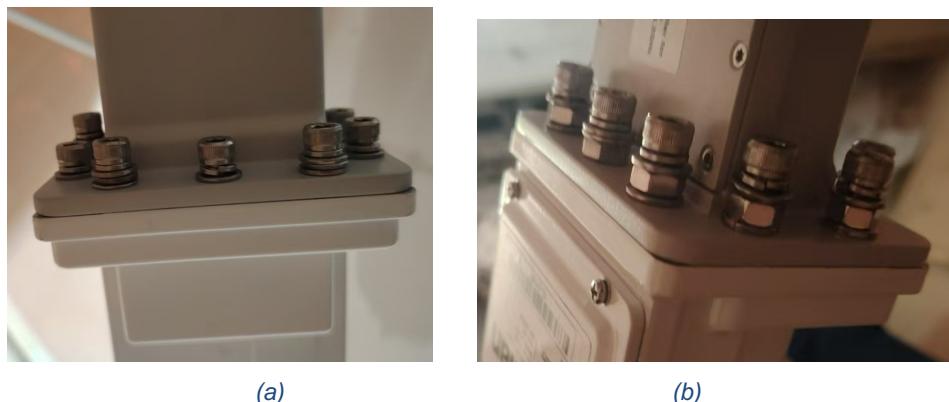
**Figure 10** The installation of 5G rejection BPF. (a) The original connection status of the interface between LNB (on the top) and the BPF (on the bottom), and (b) the reconnected and tightened interface between the LNB and the BPF.

To verify this speculation, the customer was initially instructed to wrap the entire LNB and its interface to the BPF with aluminum foil. This action resulted in an interference reduction of nearly 20 dB. The customer also provided a close-up photo of the connection interface between the LNB and BPF as shown in **Figure 10(a)**.

Typically, most LNB models feature through-holes on their flanges, allowing the LNB and BPF to be securely tightened together using screws and nuts on both sides of the interface. However, the LNB used in this specific installation case is different: It has only tapped blind holes on its flange, preventing the use of nuts on the opposite side. The screws used in **Figure 10(a)** are visibly longer than necessary. Even with addition of extra washers, the connection remained insufficiently tight, leaving imperceptible gaps that allowed 5G interference to enter.

For this reason, we recommended reinstalling the BPF using bolts that were pre-assembled with nuts as shown in **Figure 10(b)**. This approach ensures the LNB-BPF assembly can be properly tightened before the bolts reach the end of the blind holes on the LNB flange.
