AsiaSat: A Real-World Case in Solving a Problem with BPF Installation

AsiaSat Engineering Department – White Paper

HU Hai, Senior Communications Systems Engineer, AsiaSat

April 2020

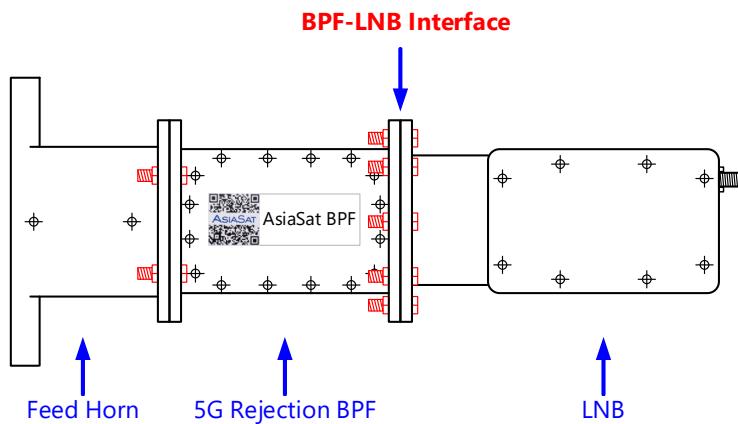
Figure 9 Connection between antenna feed horn, 5G rejection BPF and the LNB.

- the location of the nearest 5G base station
- satellite dish type
- LNB type
- the quality standard of the BPF installation (i.e. BPF-LNB interface) (see **Figure 9**)

The guidelines are set out in **Table 1** below, with the most important tip being to make sure that the BPF-LNB interface is tightly connected. If the LNB used is similar to the one shown in **Figure 2(a)**, it may be better to upgrade it with a model having standard waveguide flange and full-metallic body enclosure. For a step-by-step installation guide, please watch the video on **our website**¹.

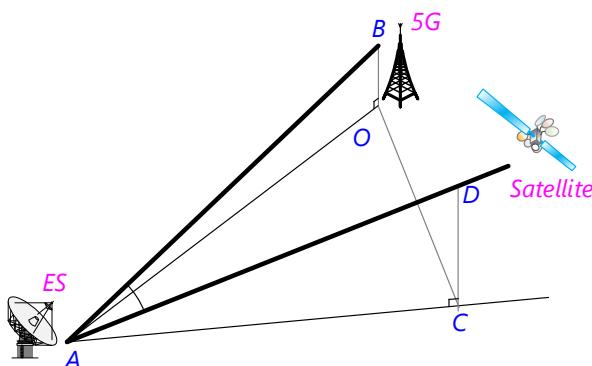
Figure 10 Relative position of the satellite earth station (ES), 5G base station (5G) and the GEO satellite, where line AB is the line-of-sight distance and $\angle BAD$ is the angular separation of the 5G base station and the GEO satellite seen by the ES.

Step 1. 5G Base Station Location	<ul style="list-style-type: none"> Coexisting condition: <u>distance to ES > 100 m</u>, and <u>angular separation > 10°</u>. Refer to Figure 10 for the illustration. Single BPF solution may not be sufficient if neither the distance nor the angular separation condition can be met. Make sure the interference comes from 5G band if the spectrum plot is available.
Step 2. Satellite Dish Type	<ul style="list-style-type: none"> Backside-fed dish (e.g. Cassegrain type) is easy to have BPF installed without interrupting the feed horn. Front-fed dish (e.g. primary focus type) is recommended to connect the BPF with the LNB on bench first, tighten all connection screws and then mount them back to the feed horn for the best installation quality.
Step 3. LNB Type	<ul style="list-style-type: none"> LNB body is better a full metal cavity design. LNB input waveguide port is better to be standard WR229 flange.
